CASE STUDY AEC

BRIDGE INSPECTIONS

GEOZICHT ACHIEVES ENTIRE TRAFFIC BRIDGE INSPECTION

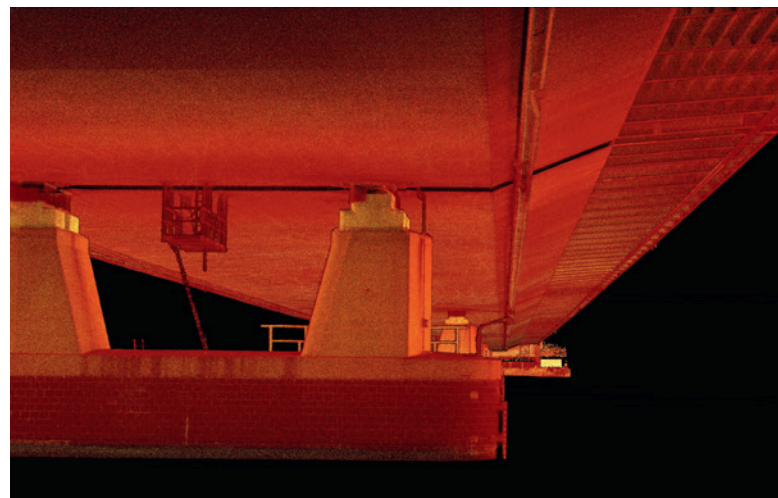
GeoZICHT captured sharp inspection images under the bridge deck thanks to a stable drone flight enabled by Hovermap's GPS-denied flight capabilities.

GeoZICHT spent three days capturing the inspection data for the bridge. To do this, they used Hovermap mounted beneath a DJI Matrice 300 RTK to provide position control with a high resolution RGB camera on top to capture the images. Hovermap acted as a virtual safety bubble around the drone to prevent contact with the bridge while also enabling stable flight behavior and, as a result, the collection of sharp and actionable inspection data.

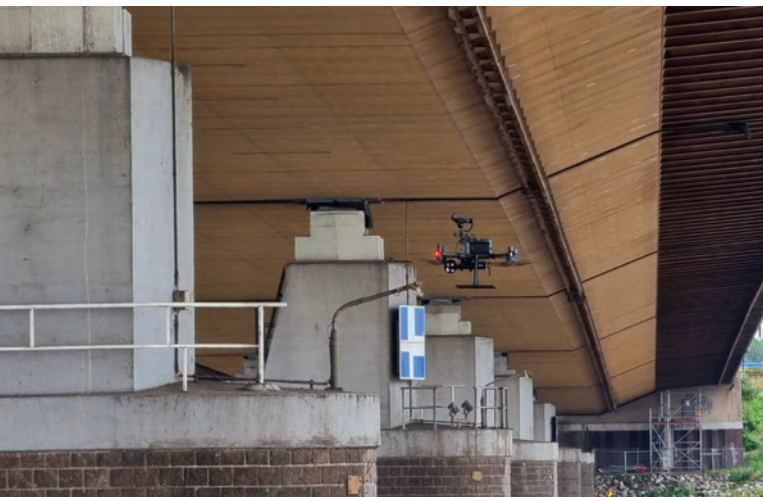
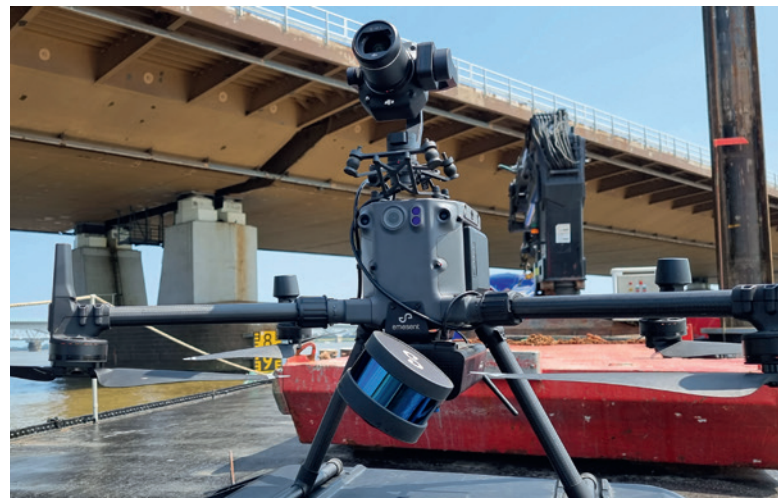
With Hovermap mounted beneath the drone and a high resolution RGB camera on top, GeoZICHT captured sharp and actionable inspection data of the complete bridge.

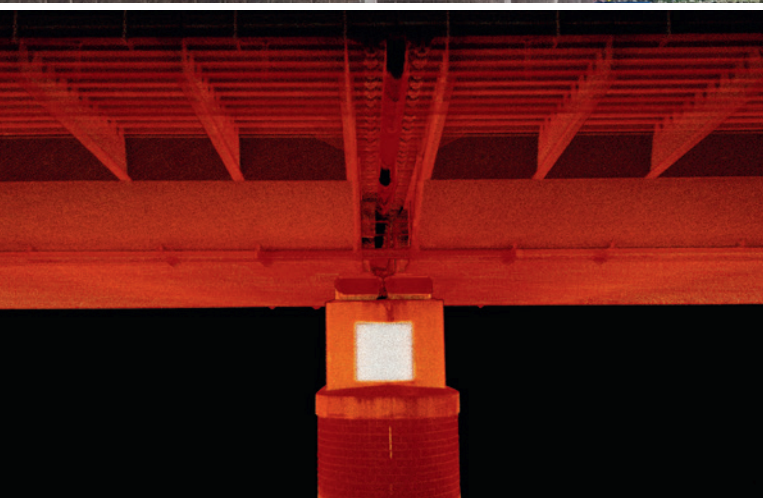
Hovermap acts as a virtual safety bubble around the drone, preventing contact with the bridge.

Hovermap's Pilot Assist mode provided the team with collision avoidance that allowed them to maintain a safe standoff distance from the bridge while still getting close enough to collect sharp and detailed images for an optical inspection.

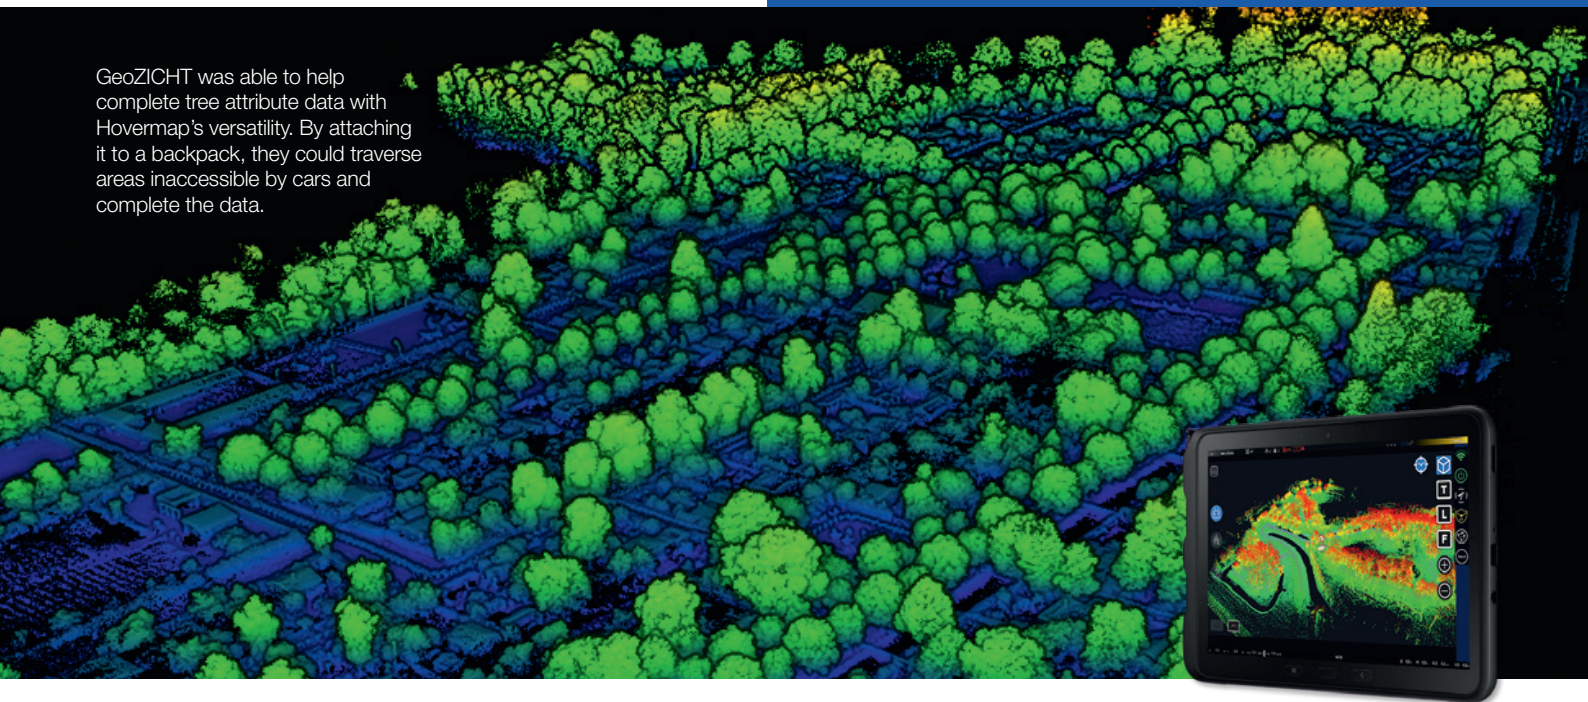
GeoZICHT was able to help complete tree attribute data with Hovermap's versatility. By attaching it to a backpack, they could traverse areas inaccessible by cars and complete the data.

In order to circumvent these accessibility constraints, GeoZICHT mounted their Hovermap unit to a backpack. By walking or cycling through the areas that couldn't be accessed by car, they could successfully collect complete LiDAR point cloud data in a timely manner that, until recently, still proved rather hard to access.
